**CRASH INJURY INVESTIGATION**

**HU-1A BELL IROQUOIS HELICOPTER ACCIDENT**

**East St. Louis, Illinois**

**21 October 1959**

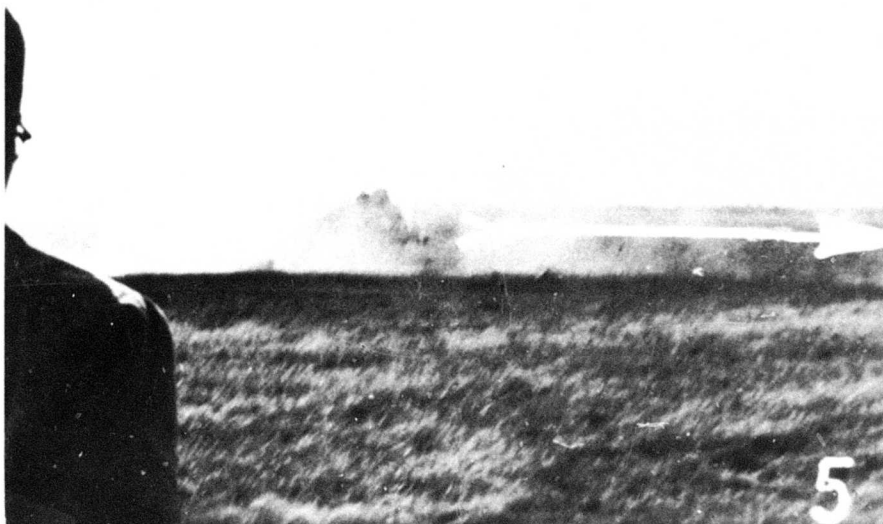
Fig. 5. HU-1A rolling to rest (about 410 feet along crash path). Arrow indicates direction of travel of engine.

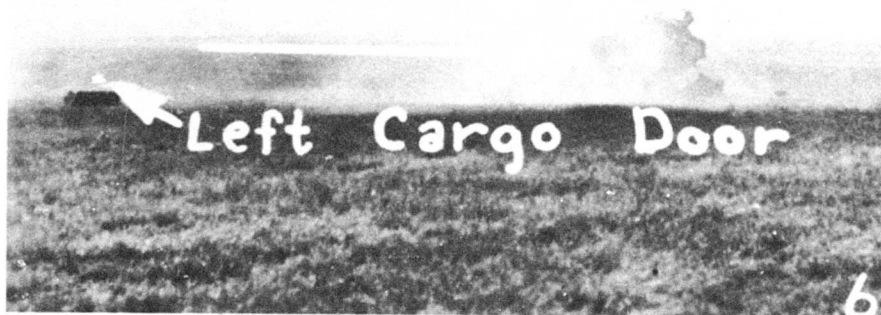
Fig. 6. HU-1A at rest (about 420 feet along crash path) inverted.

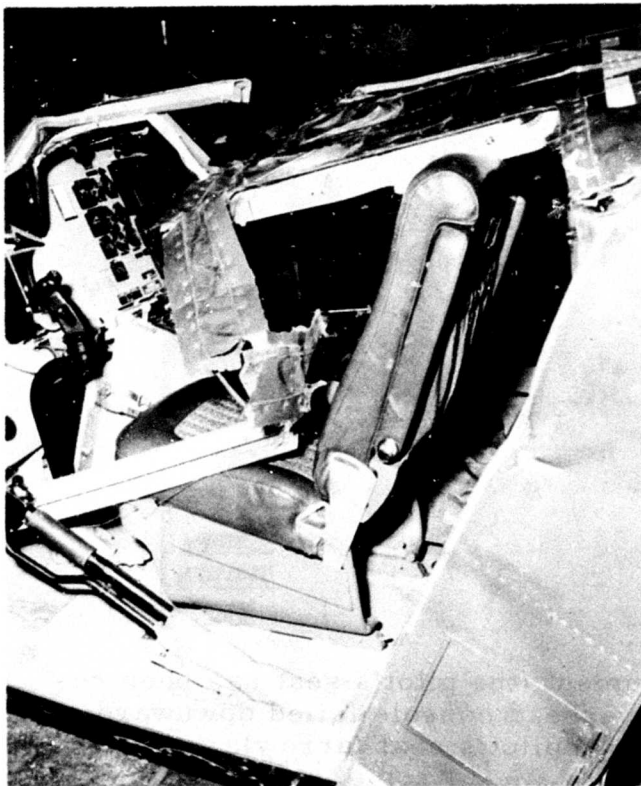
The instrument panel, even though loosened by impact forces and displaced slightly forward, sustained very little damage and remained intact. (See Fig. 22, p. 17; Fig. 31, p. 21).

Fig. 22. Instrument panel broke forward (away from occupants) during crash (arrow).

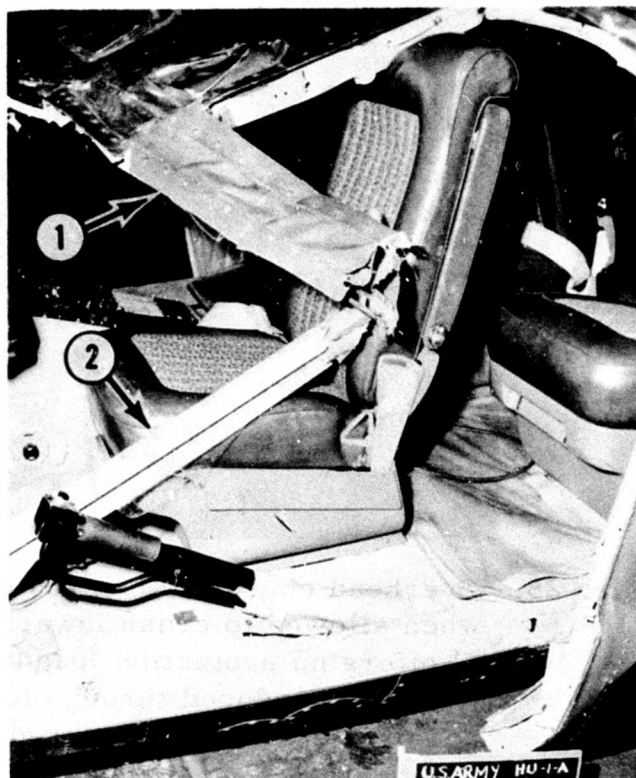
Fig. 23. Copilot's (left) overhead window frame (arrow 1) and left forward door post (arrow 2) were crushed inward.

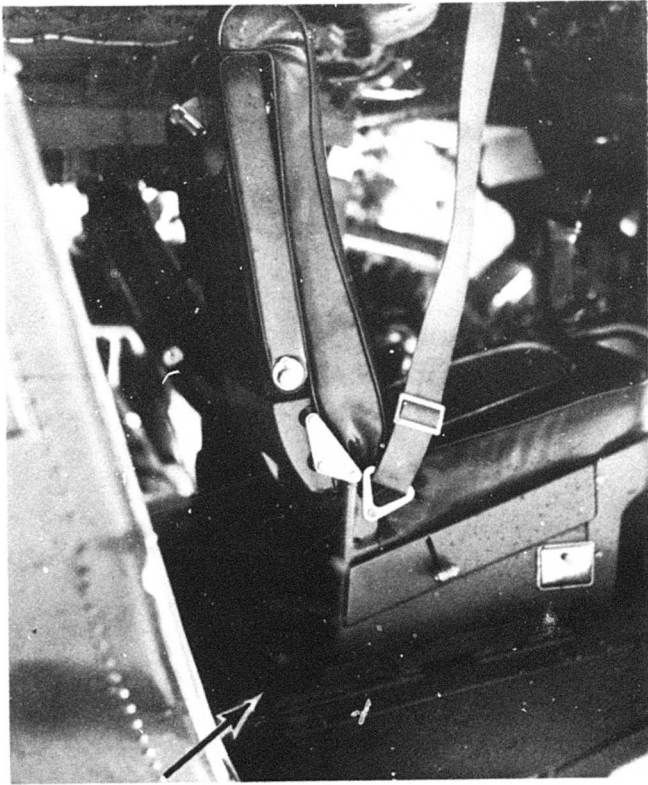
The pilot's and the copilot's seats were individually mounted on large, flat supporting plates with tracks for forward and aft adjustment. (See plates and track fittings in Figs. 56-58, p. 35 ff.). The three individual seats across the center of the cabin were mounted on one large plate. The triple seat across the aft end of the cabin was supported by tubular structure in the usual manner for Army troop seats.

Fig. 56. Pilot's seat is shown installed in the HU-1A. Mounting plate, upon which seat tracks were mounted, was held to aircraft floor with 16 bolts.

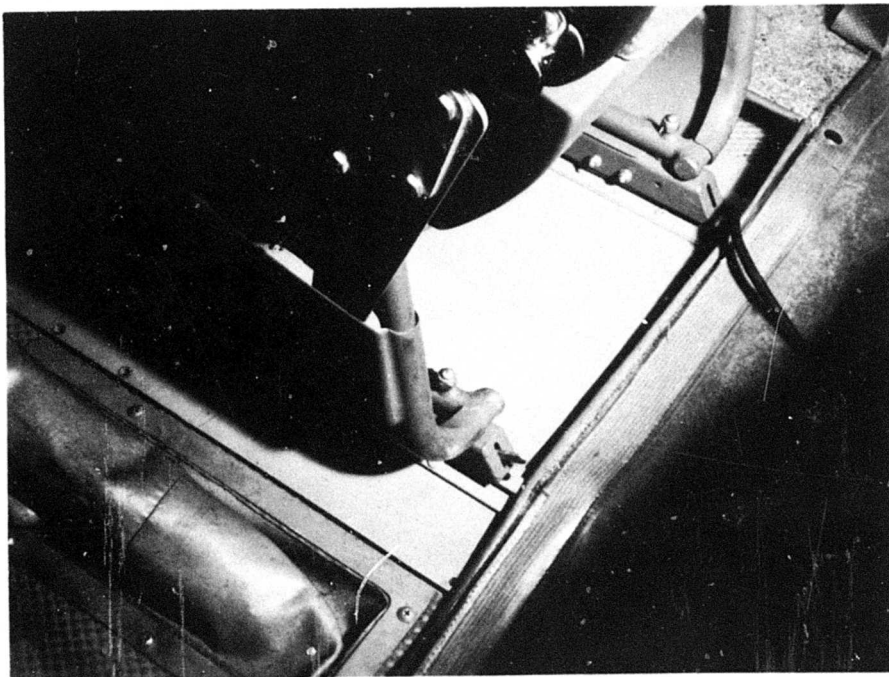
Fig. 57. Seat tracks on mounting plate afford fore/aft adjustment.

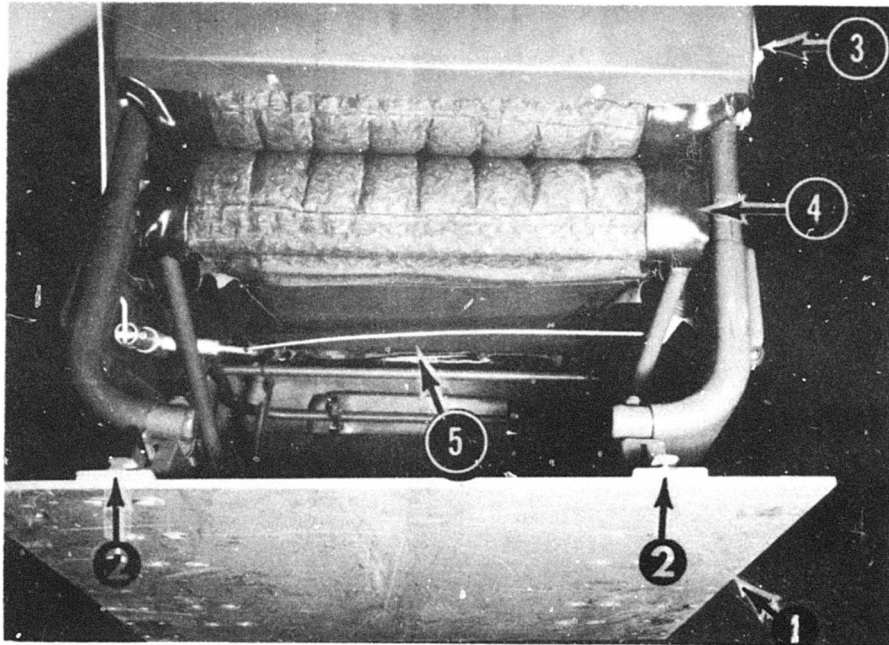
Fig. 58. Seat mounting plate (arrow 1), seat track (arrow 2), seat back (arrow 3), seat cushion (arrow 4), and seat bottom (arrow 5).

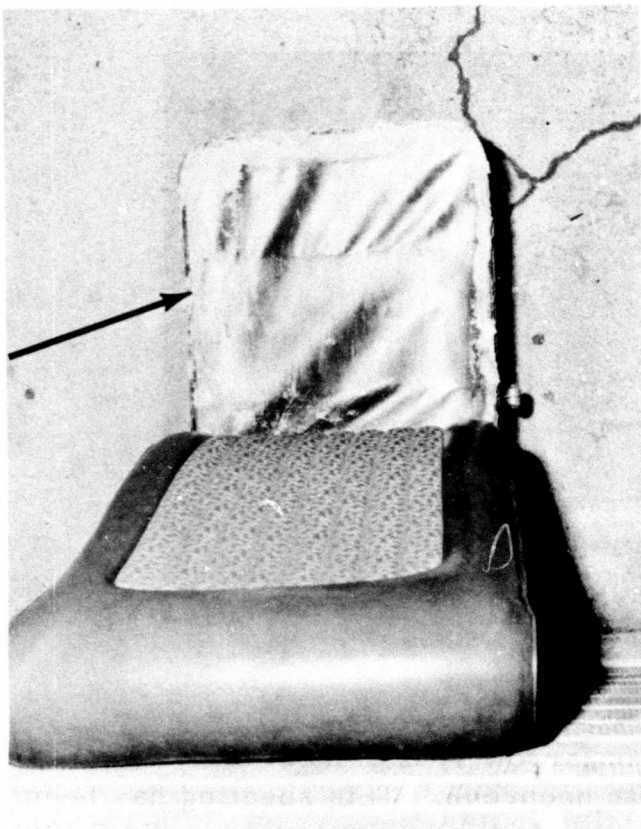
Fig. 62. Top view of seat pan.

The seats are model TE 432F-2, constructed on a frame of chrome-moly aircraft-grade tubing (SAE 120), and have a cushion of 4-inch polyurathane foamed material. The seat pan is a sheet of nylon, impregnated with neoprene, drawn very tightly over the tubular frame and bonded securely. (See Figs. 59-63, p. 36 ff., showing stripped seats).

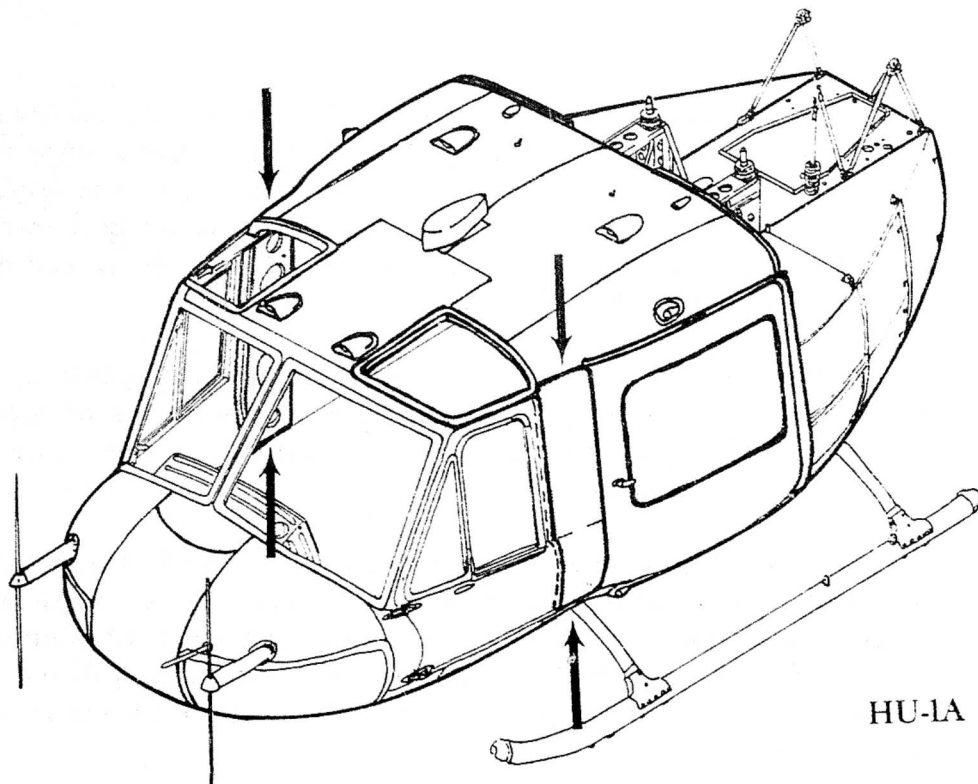
Fig. 67. Reference drawing to illustrate structure referred to in Figs. 45 and 46.

Fig. 35. Right side fuselage (seats removed). Note compression and failure of vertical overhead support member, which allowed overhead structure to crush downward. (See Fig. 67).

The extreme forward portion of the roof is supported by the front door frames and a center strip of the windshield frame structure. (See structural drawing and photographs of damage in Fig. 17, p. 14; Fig. 67, p. 44). Both forward door frame members and the windshield frame in the center failed completely, and the forward edge of the overhead structure crushed inward 18 to 24 inches.

Fig. 66. Left side of fuselage (seats removed). Vertical overhead support (arrows) failed. (See Fig. 67).

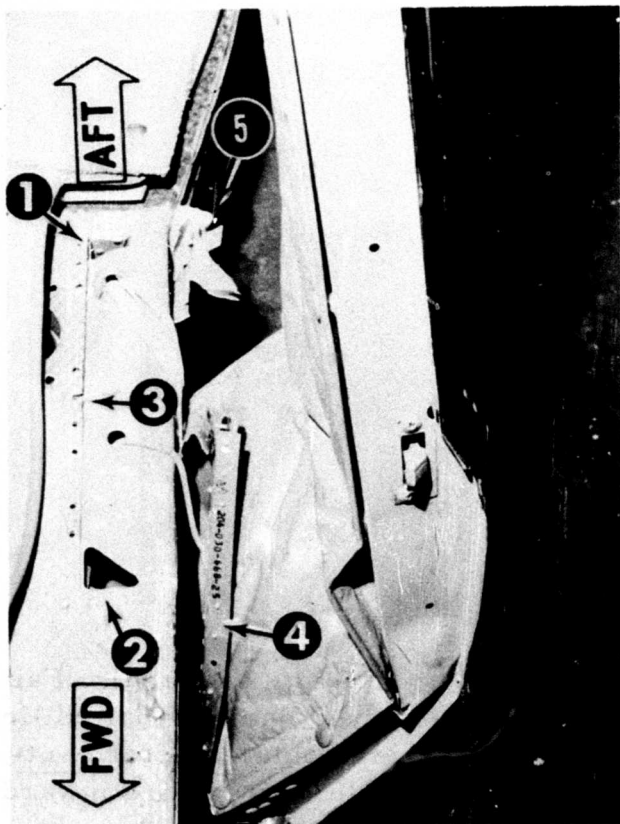
Fig. 71. Structural integrity of the vertical support member (which also serves as door frame for forward and cargo doors) depends on the strength of "L" stringers (arrows 1 and 2) and of the inner skin attachment method (arrows 3 and 4). The outer skin attachment system is pointed out by arrow 5.

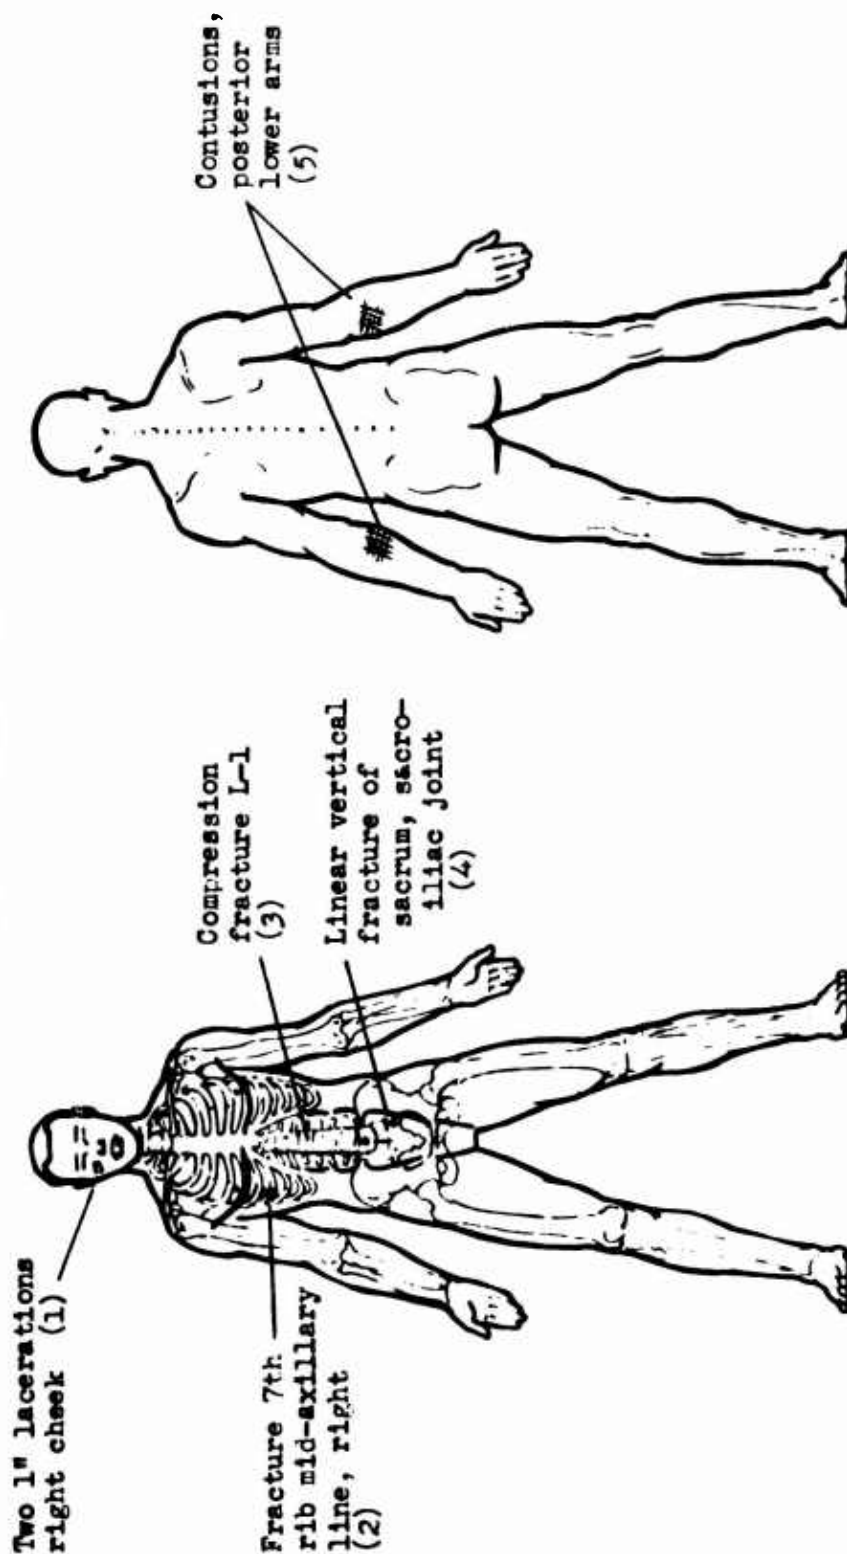
## PILOT - Right Seat

1. Cause undetermined
2. Possibly caused by striking cyclic
3. Possibly result of load amplification
4. Cause undetermined
5. Cause undetermined

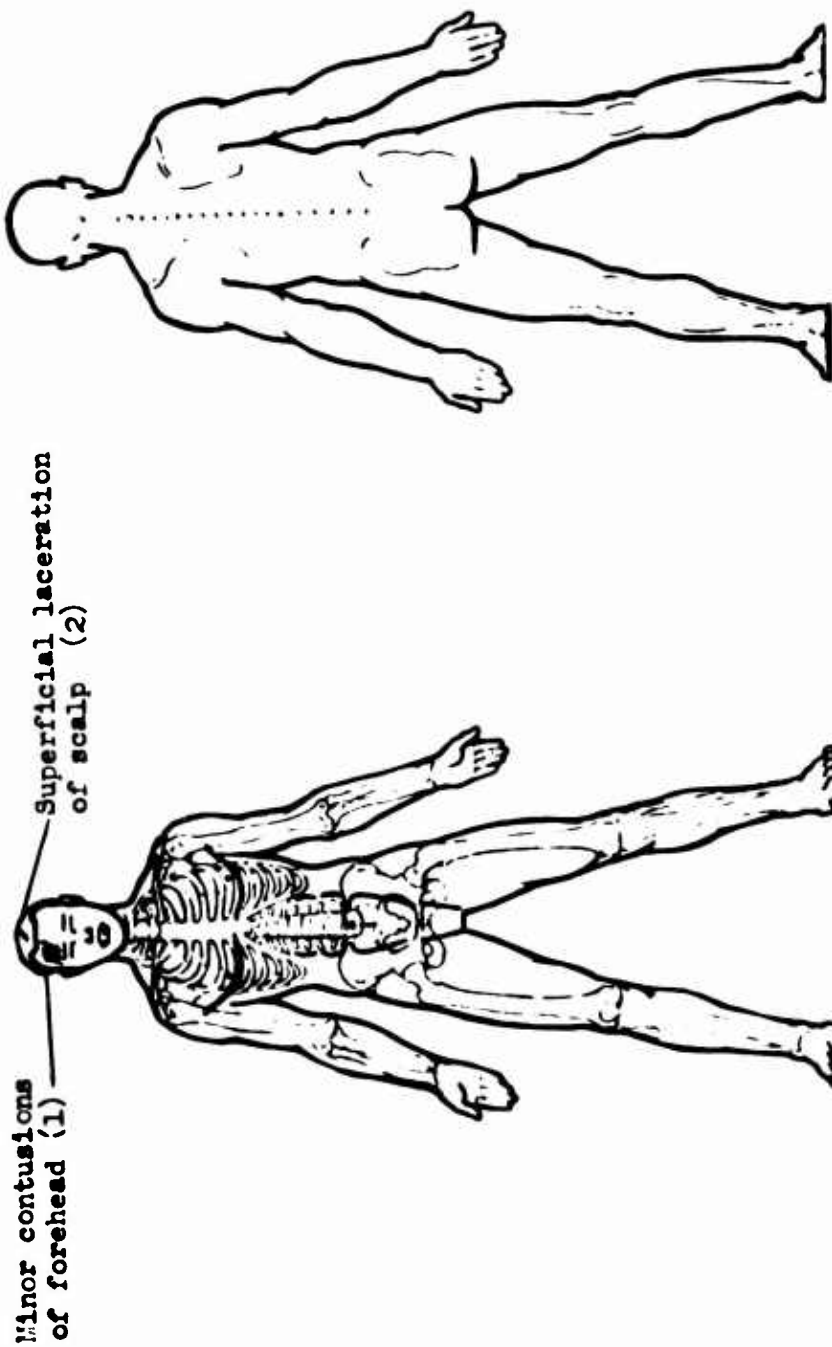
CREW CHIEF - Left Seat

1. Cause undetermined
2. Cause undetermined
